## **CMC Bozeman Facility Supplemental Investigation Report**

**City of Bozeman**

Tetra Tech Project No. 1157720035.200

January 6, 2009

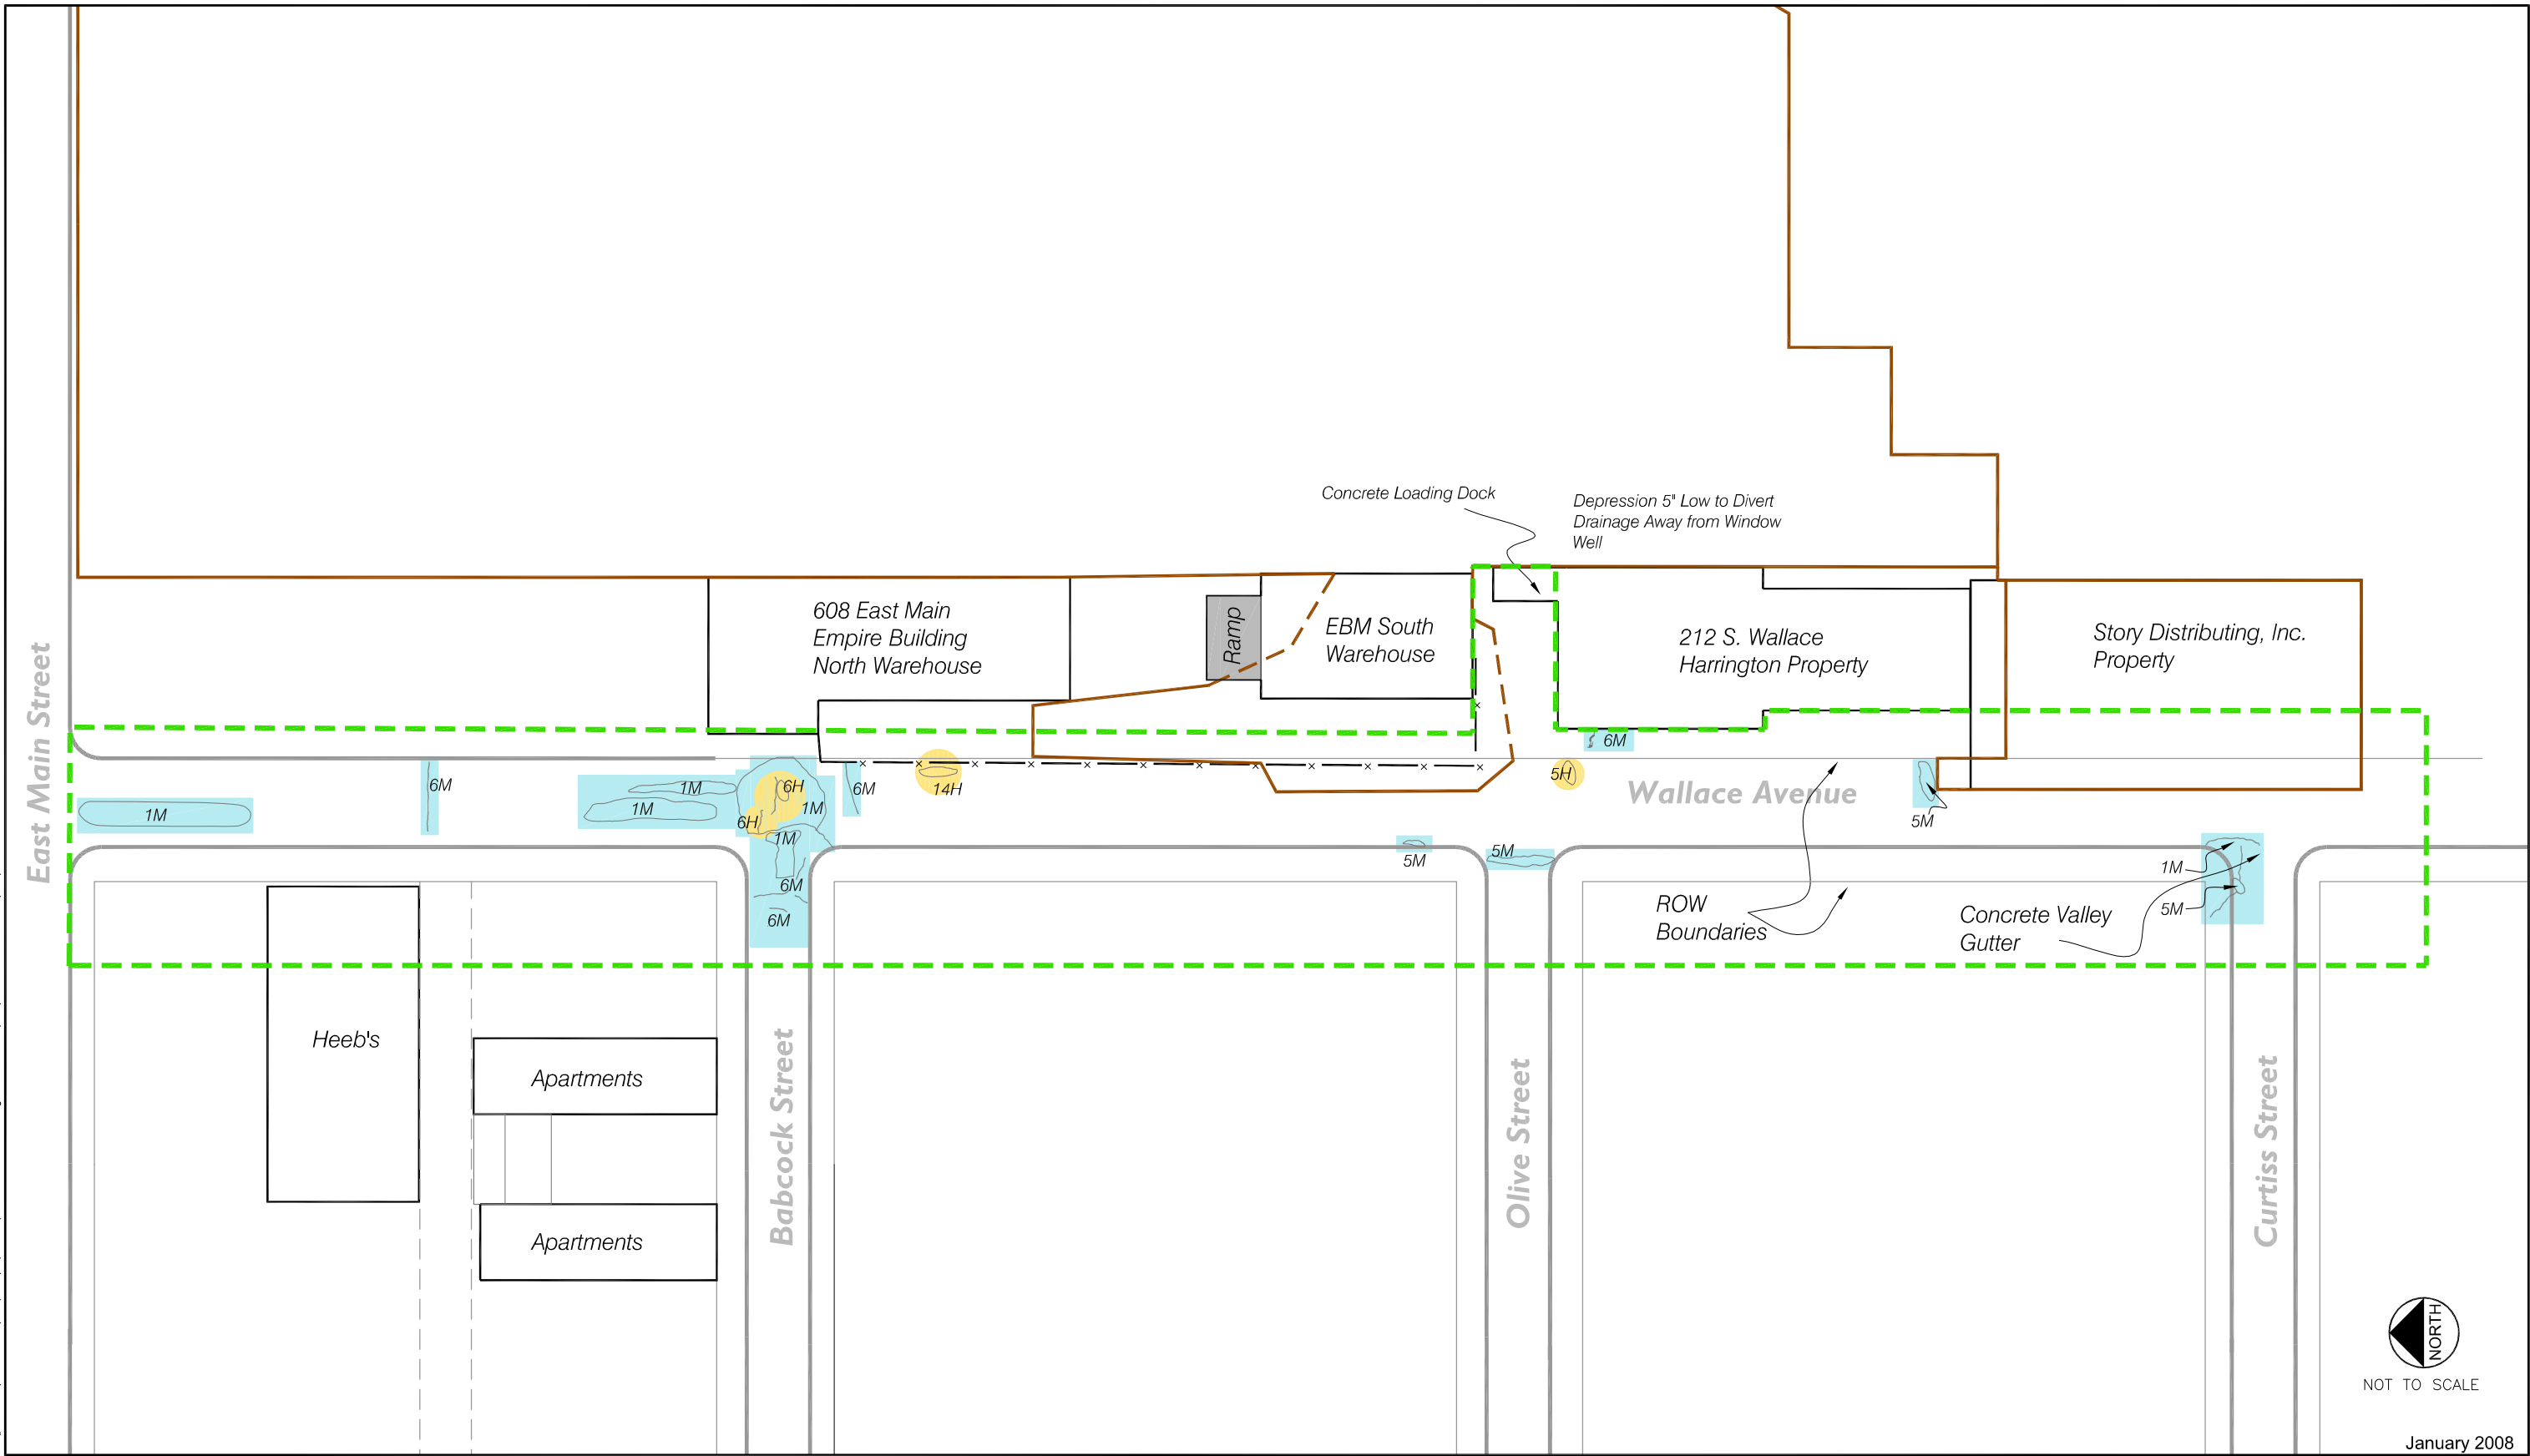
Asphalt Pavement Condition  
Areas of Suspected Asbestos Ore  
CMC Bozeman Facility  
Bozeman, Montana  
FIGURE 3

It should be noted that within these street segments localized areas of Moderate or High levels of deterioration exist. **Figure 3** outlines the “damaged” asphaltic pavement areas of South Wallace Avenue. Areas that are not defined contain no damage. **Table 2** provides documentation of the concrete surfaces that were considered to have High or Moderate deterioration. This includes sidewalks, gutters, curbs and portions of some driveways. This data is not presented on a figure because the small sizes of the features make it difficult to show at the scale of the maps used in this report.

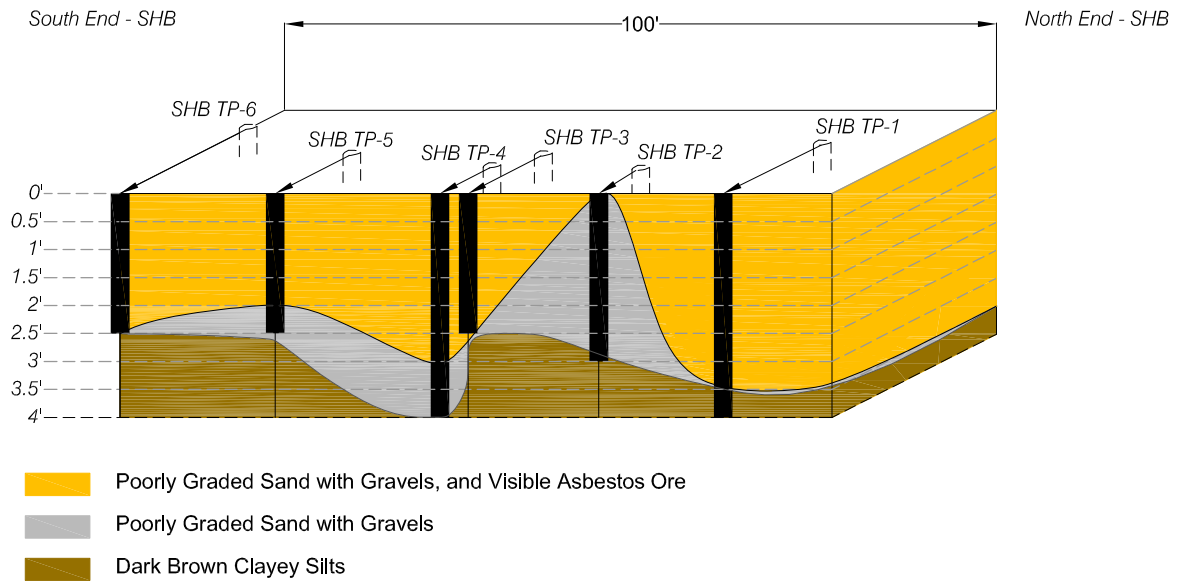
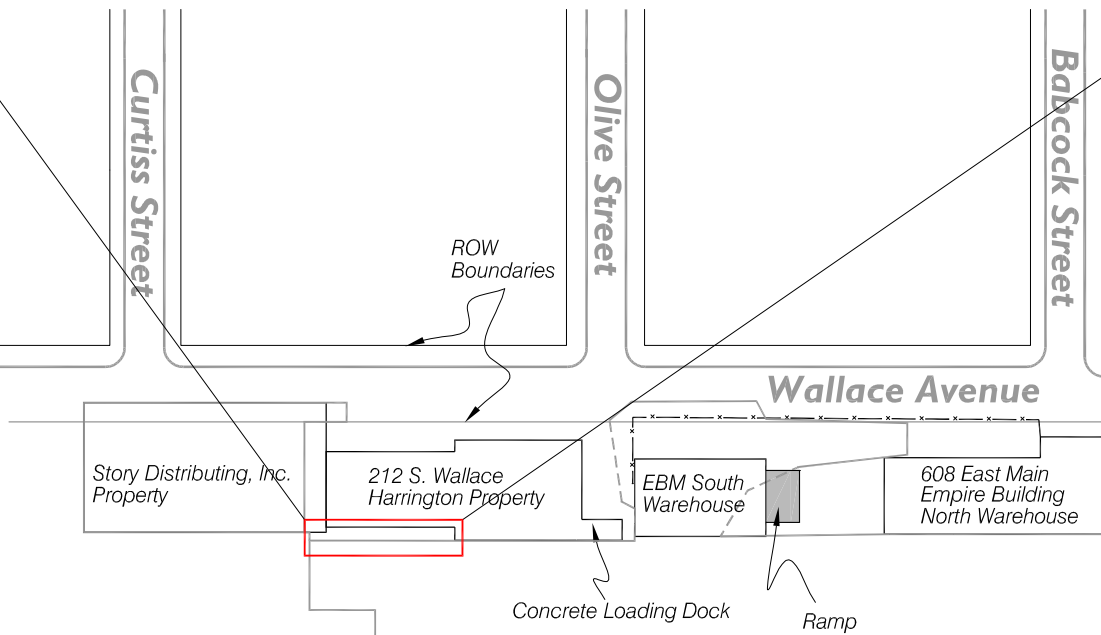
Asphalt Pavement Removal and  
Repair Recommendations  
CMC Bozeman Facility  
Bozeman, Montana  
FIGURE 4

Tetra used the PCI ratings to evaluate the potential for release of asbestos fibers in areas where asbestos may be present in soils beneath paved surfaces. Although all of these asphalt-covered areas have the potential to incur damage in the future, Tetra Tech's interpretation to the referenced ASTM Method indicates that only those areas with High or Moderate ratings contain the potential for asbestos exposure at the Facility in the immediate future. These areas are outlined in **Figure 4**.

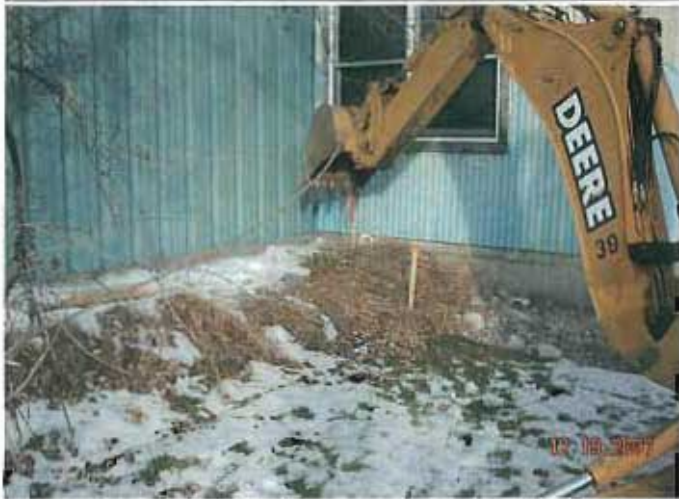
**PHOTOGRAPH 1** SHB TP-1: Located in NE corner of SHB along NHB east dock area south wall

Six test pits were excavated from the area east of the SHB and three composite and six grab samples were collected. Visible asbestos was present throughout SHB TP1, TP3, and TP6; however, no visible asbestos noted in SHB TP2. SHB TP4 and TP5 contained small visible pieces of asbestos as noted in the test pit logs and **Table 3**. Tetra Tech collected composite samples to represent the majority of soils in the test pits. Seven test pits were excavated from the Story Distributing property and, six composite and six grab samples were collected. Five test pits were excavated from the alley behind Heeb's and five composite and five grab samples were collected. After test pit sample collection, Tetra Tech's subcontractor backfilled and bucket-compacted all excavations.
